Radiometric calibration of SGLI on-orbit

Hiroshi Murakami

JAXA/EORC

Breakout Workshop of Sensor Calibration 2019 International Ocean Colour Science Meeting Busan, South Korea, 9-12 April 2019

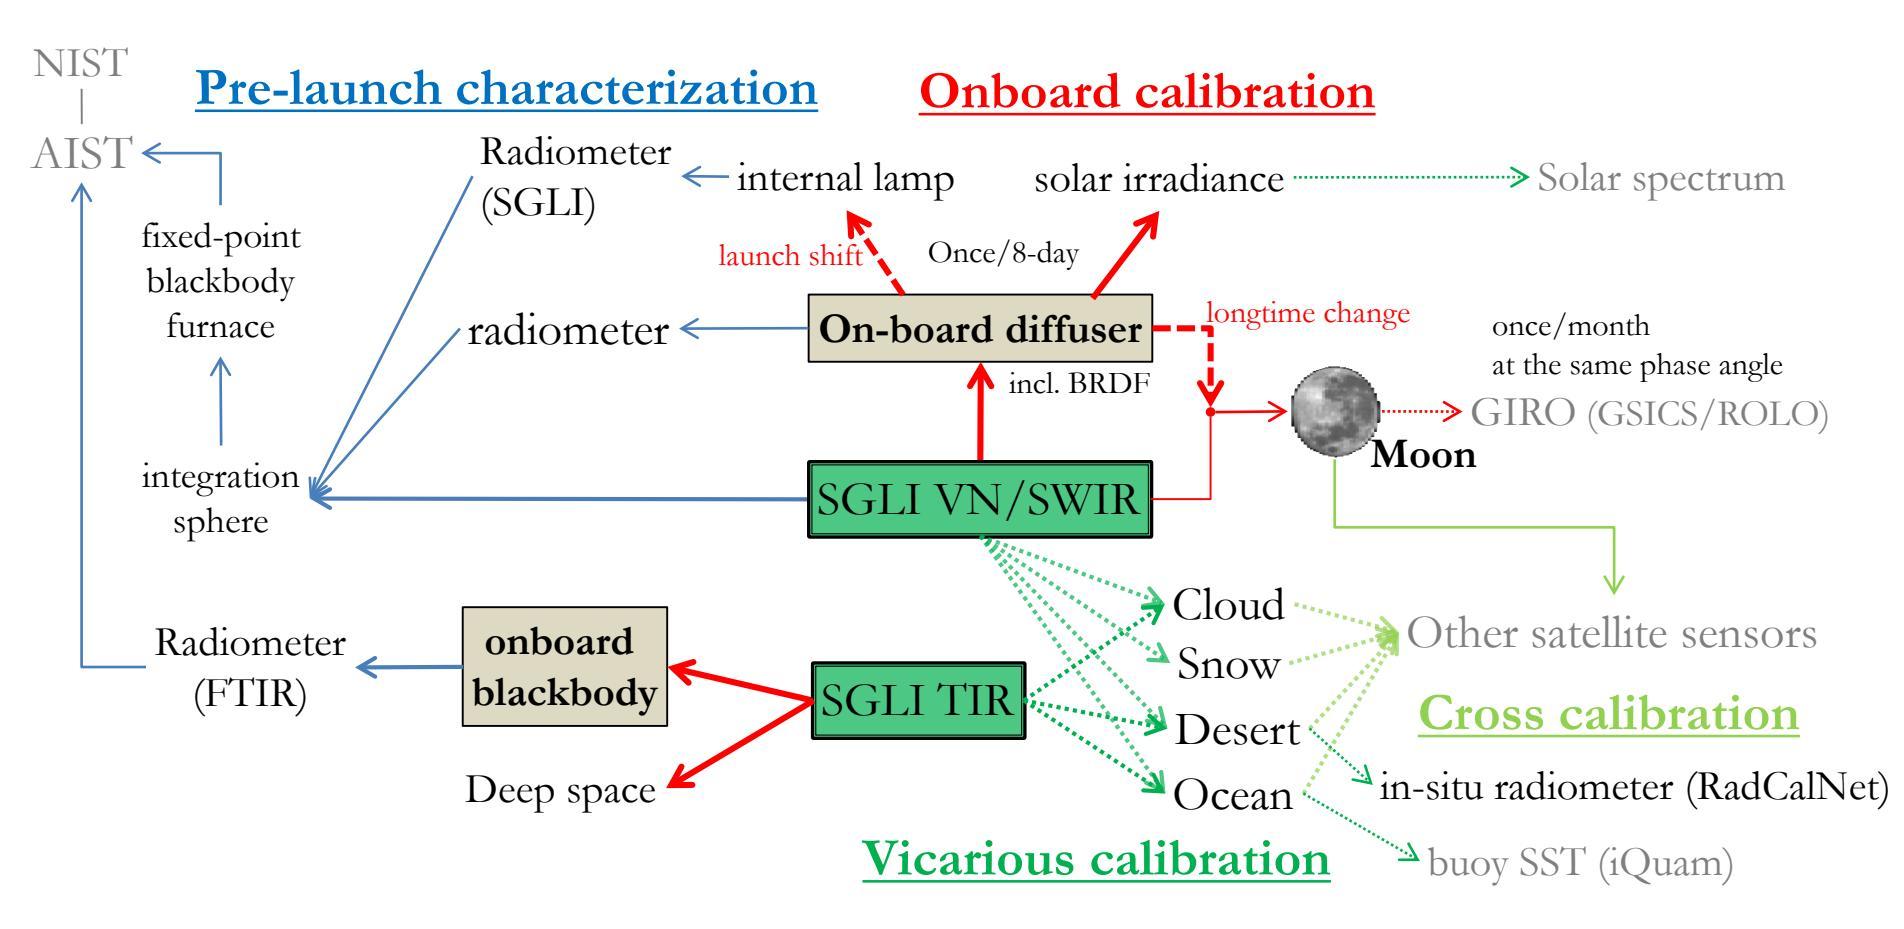
1. Radiometric calibration system

- ✓ Post-launch Level-1 calibration will be based on the <u>onboard calibration</u> with sensor model developed by the <u>pre-launch characterization</u>
- ✓ <u>Vicarious</u> and <u>cross calibration</u> will be used for confirmation of the onboard calibration, and more accurate calibration (adjustment) required for the L2 algorithms

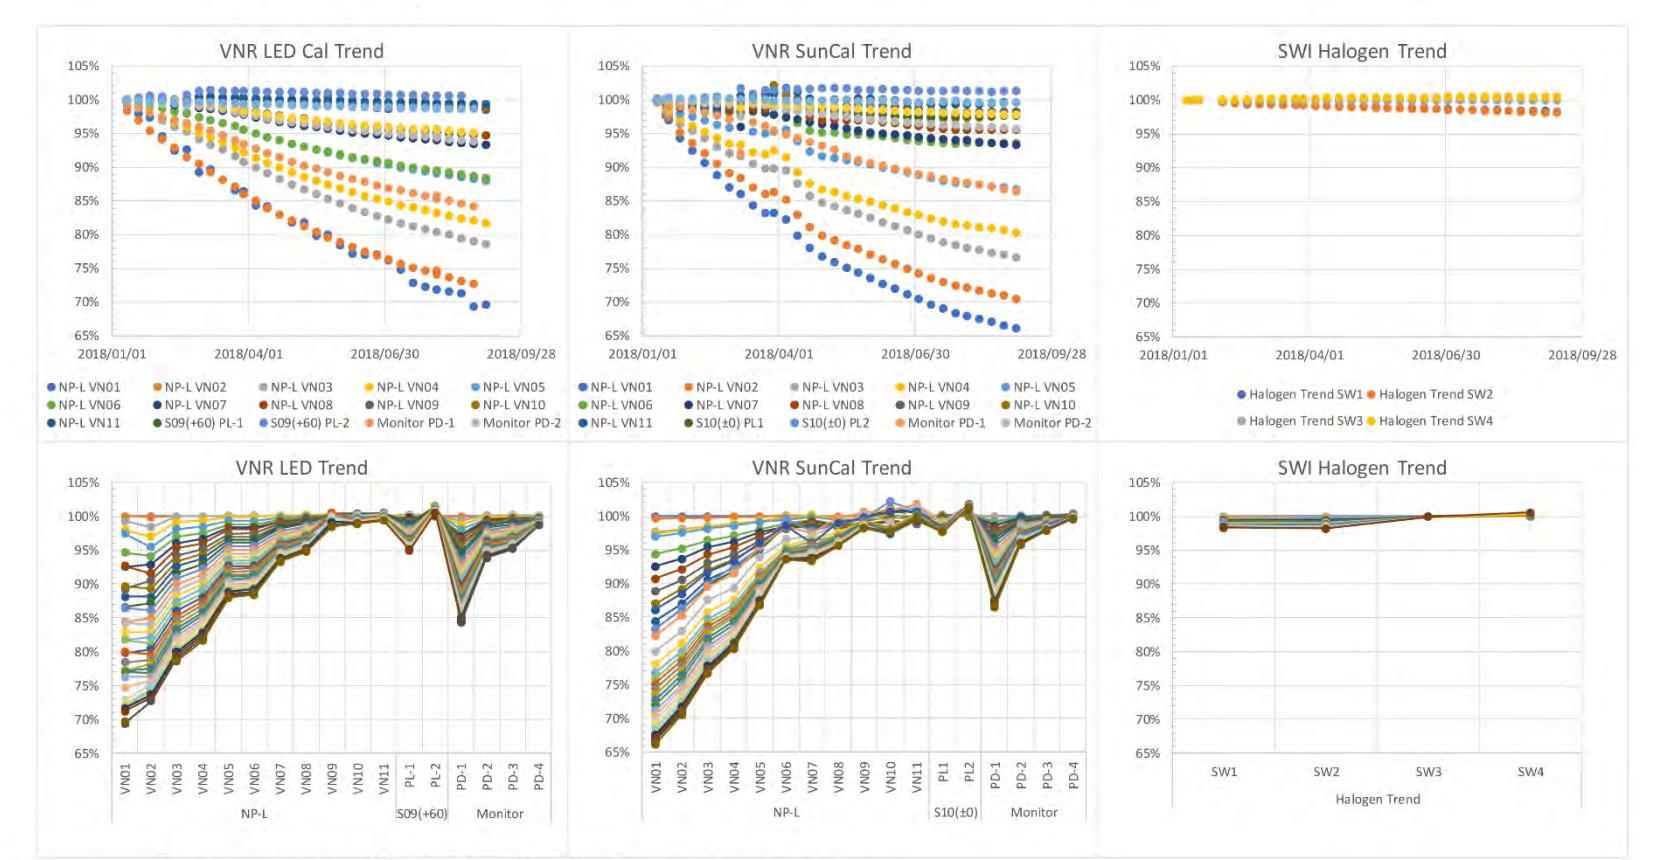
□ Solar reflective bands trend for 9 months

- Same solar diffuser degradation at both LED and Sun Calibration is observed for VNR wavelength.
- ✓ Detailed analysis and a comparison with other results is ongoing.

- ✓ Solar and lamp calibration: diffuser degradation
- ✓ Monthly lunar calibration: works well by using GIRO
- ✓ Image quality
 - Stray light correction confirmed by Moon and ocean color images
 - Inter-telescope difference is corrected by using the 90-deg yaw maneuver data over Antarctica (on 17 Feb. 2018) and overlap samples for each scene
 - Detector noise: not so significant; the remaining noise was corrected by the yaw maneuver data; further improvement is still under evaluation
 - Random noise: stable in the first year; monitored continuously

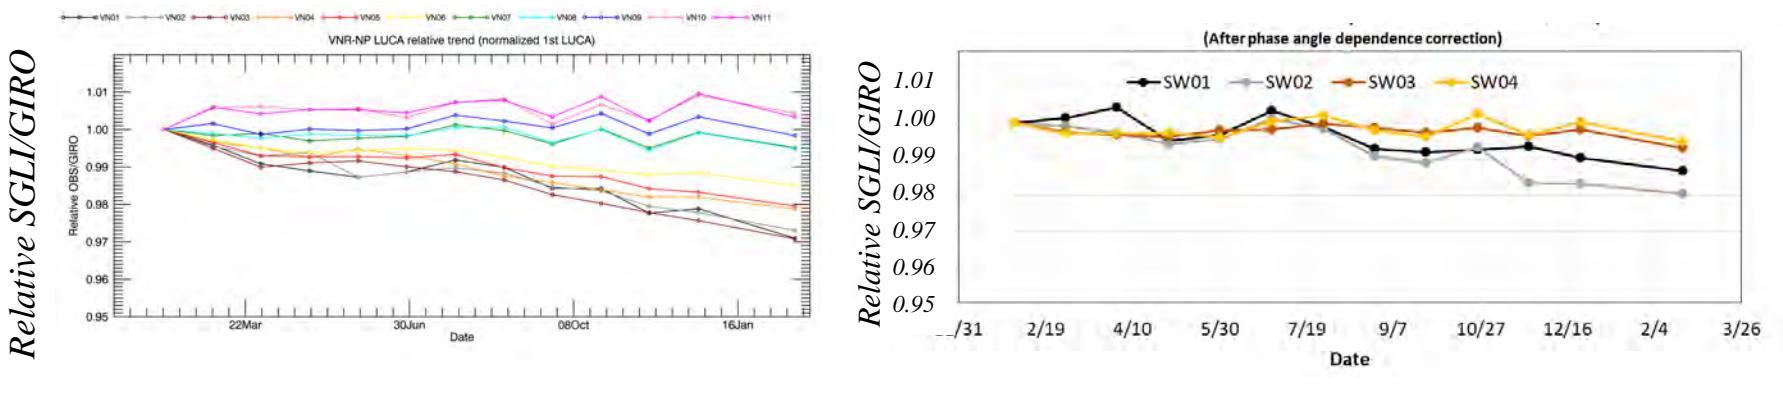
IRS-SWI relative trend (Normalized 2018/2/1) (After phase angle dependence correction)

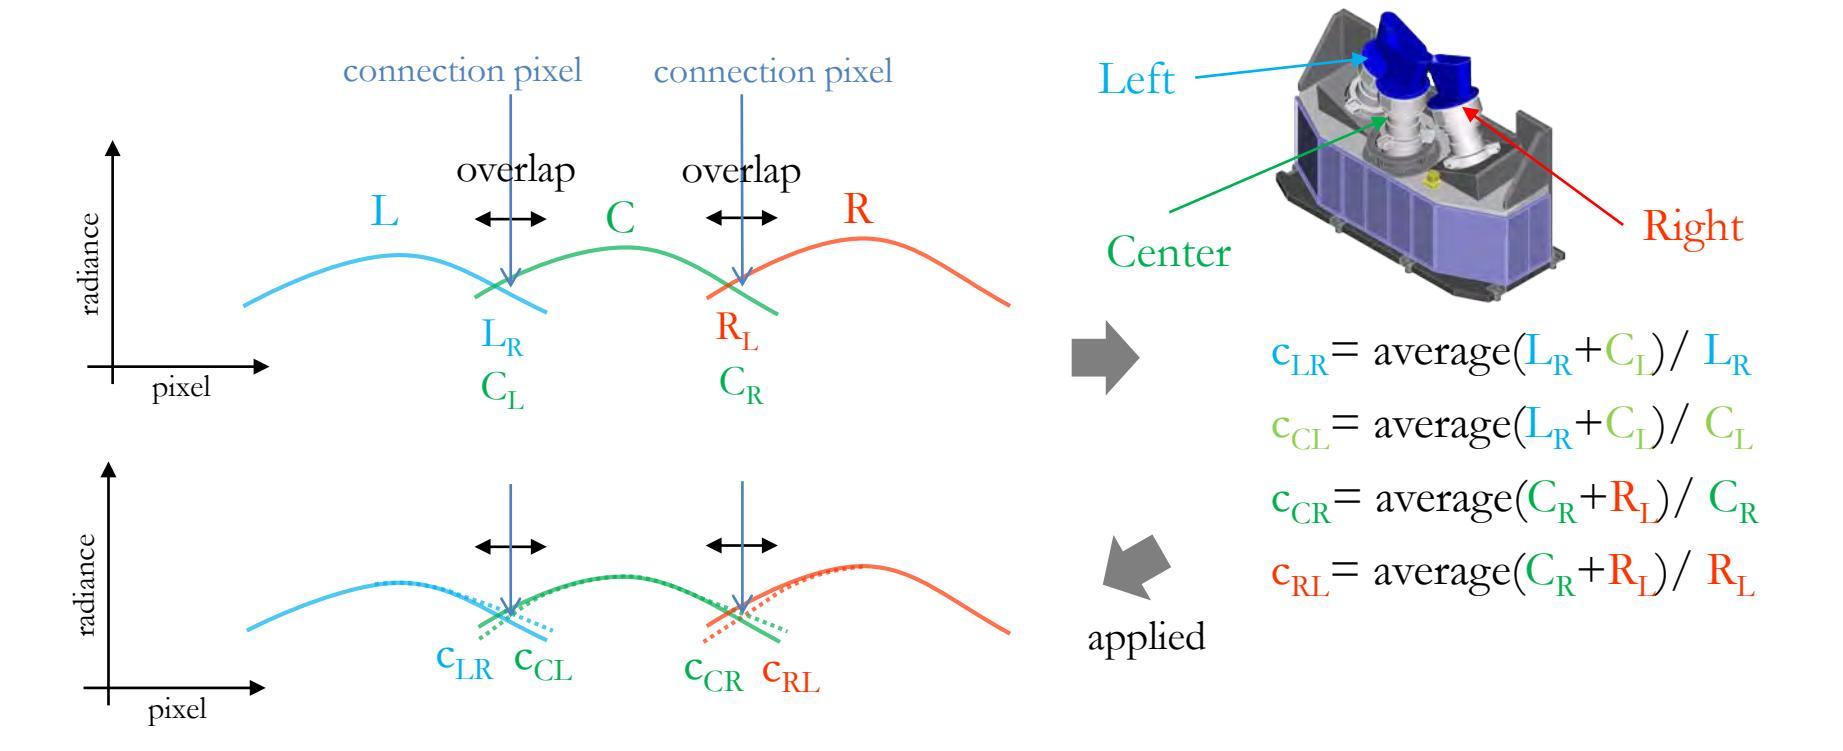
- ✓ Statistics of the overlap pixels (~112 pixels) weighted around the connection pixel (the center of the overlap)
- ✓ Correction is applied with weighting around the connection pixel
- \checkmark OC radiance range is used for the statistics
- ✓ Coefficients are changed gradually by 1500 lines (~1/4 scene)

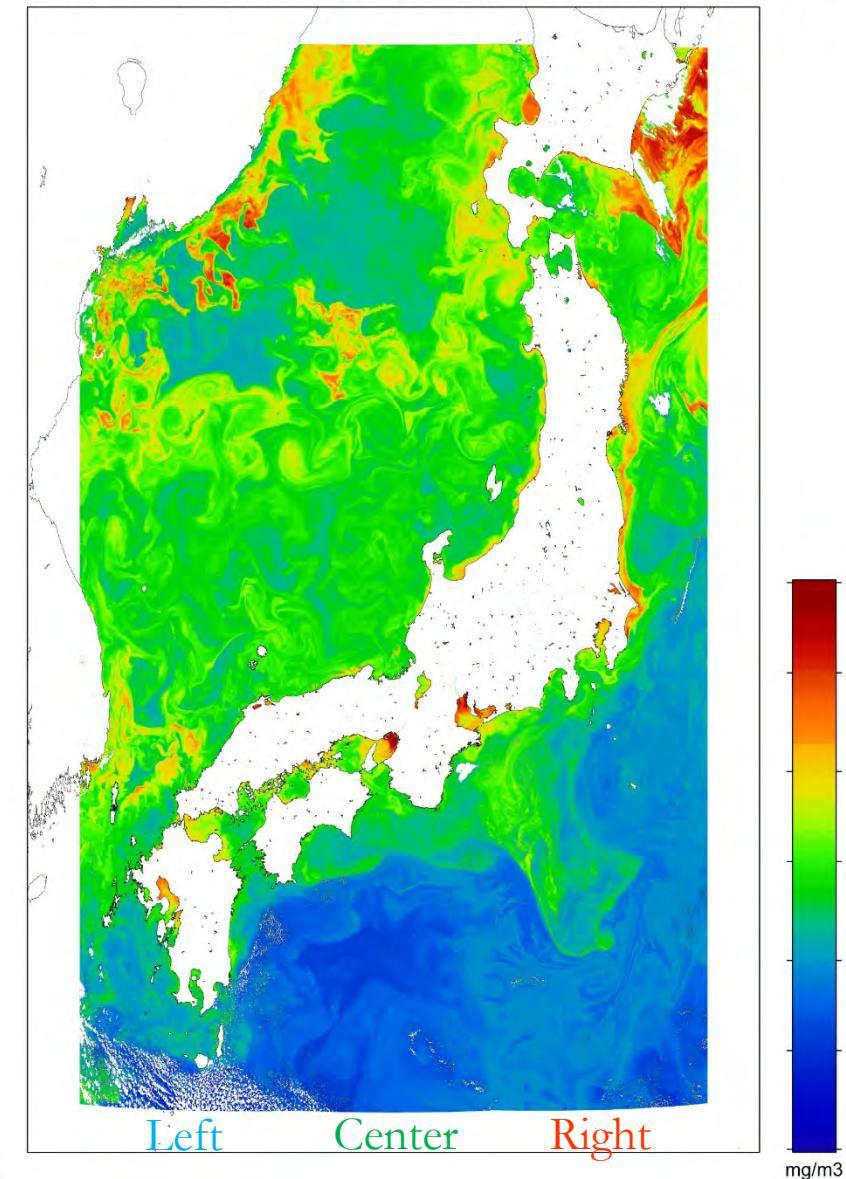
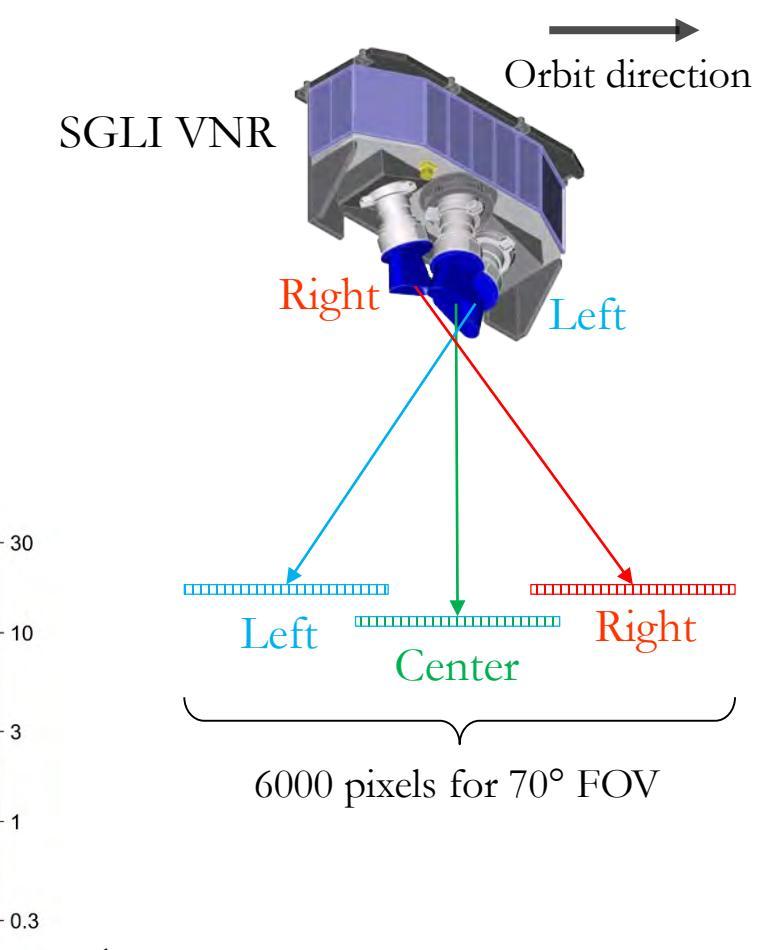
C1SG1 201804210138V05510 1BSG VNRDQ E2211.h5, 20180421 01:41:05.647, chl

✓ An example of Chl-*a* image without the table revision + gap correction

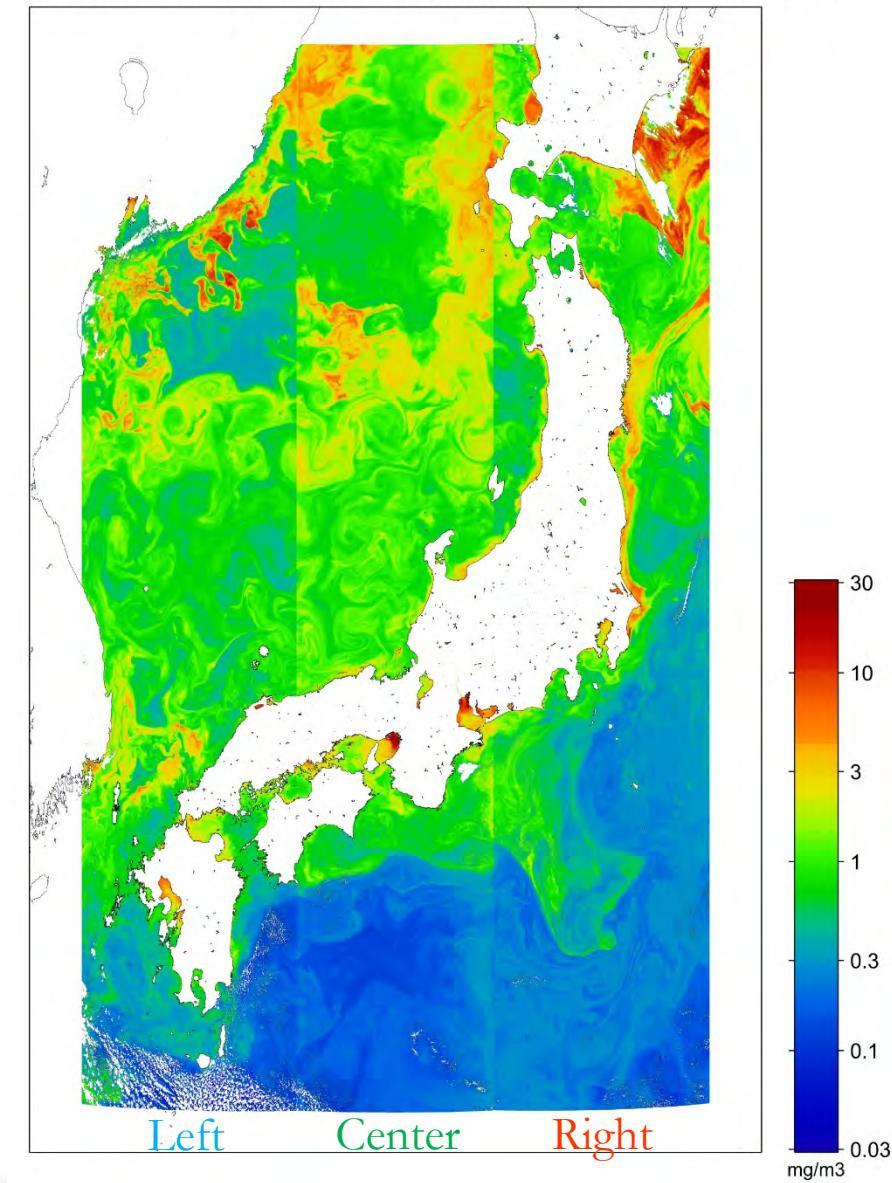
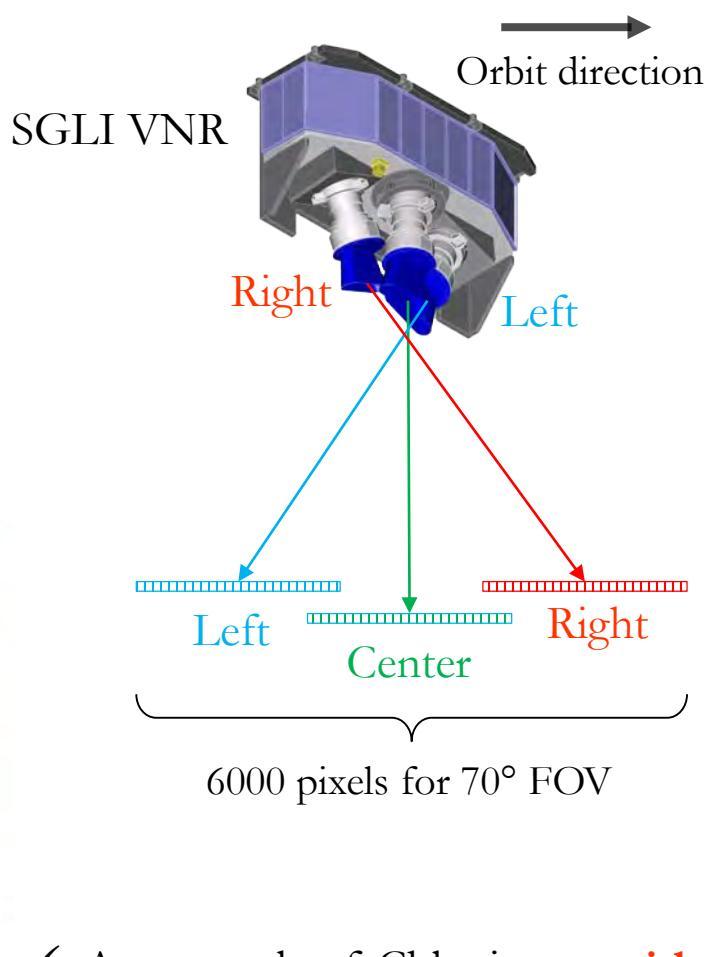
C1SG1_201804210138V05510_1BSG_VNRDQ_E0010.h5, 20180421 01:41:05.647, chl

✓ An example of Chl-*a* image without the table revision + gap correction

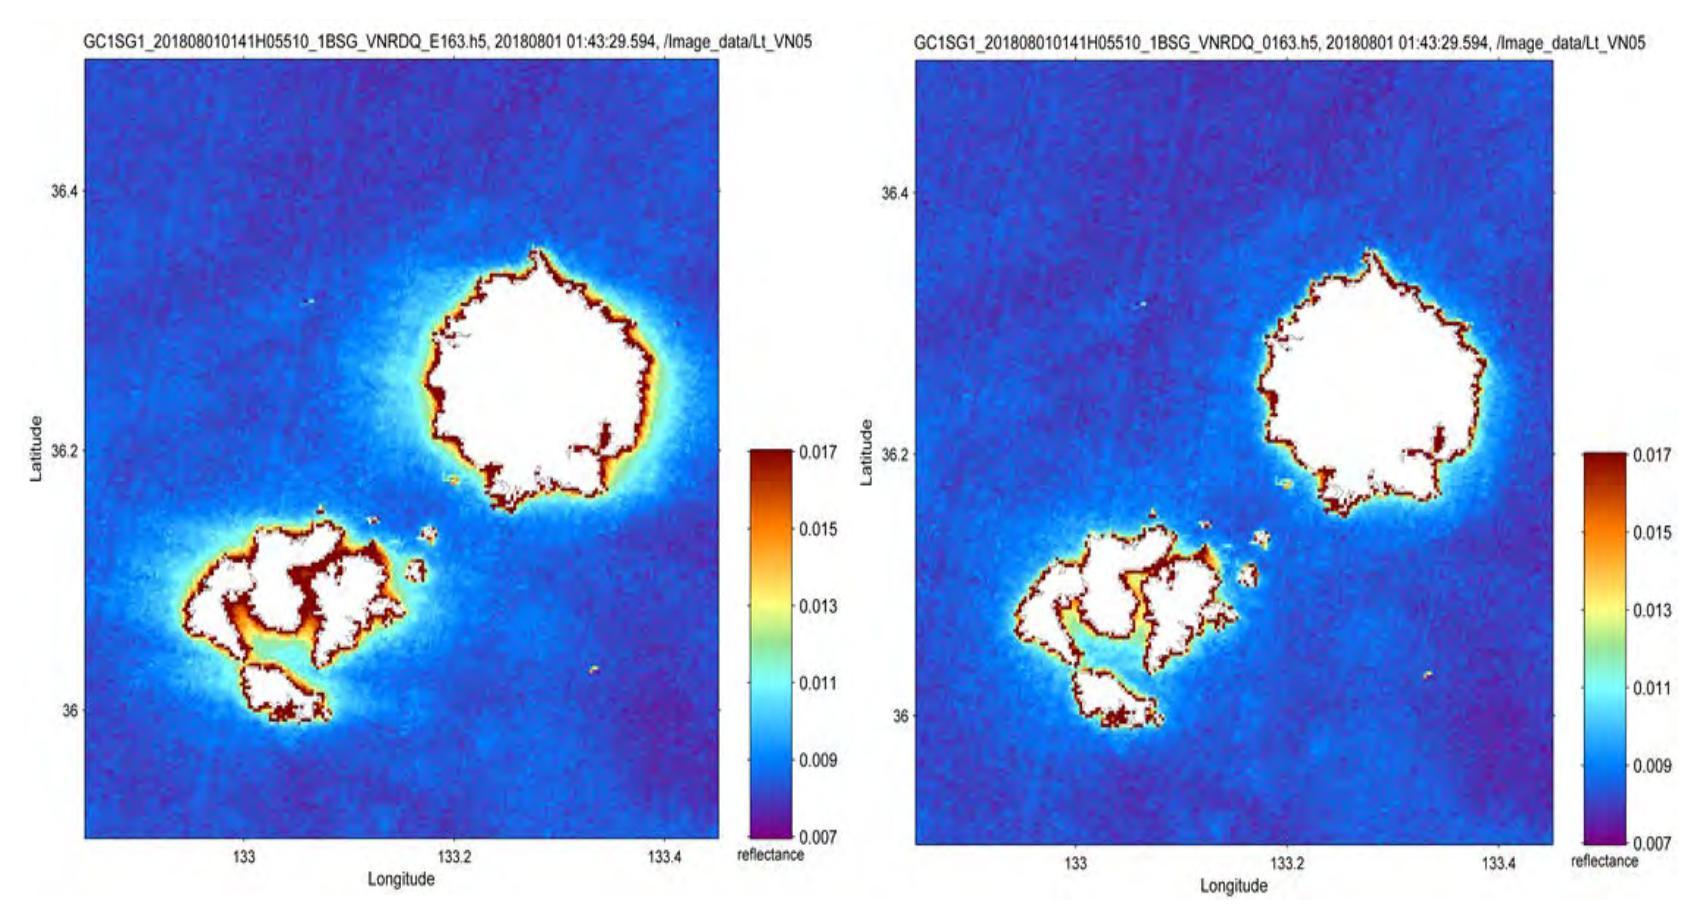
✓ The correction results are confirmed by ocean color images (e.g., ρ_w , Chl-*a*..)

Level-2 $\rho_w(530 \text{ nm})$ images with and without the straylight correction (in Level-1 processing) around Oki islands in Japan on 1 Aug. 2018.

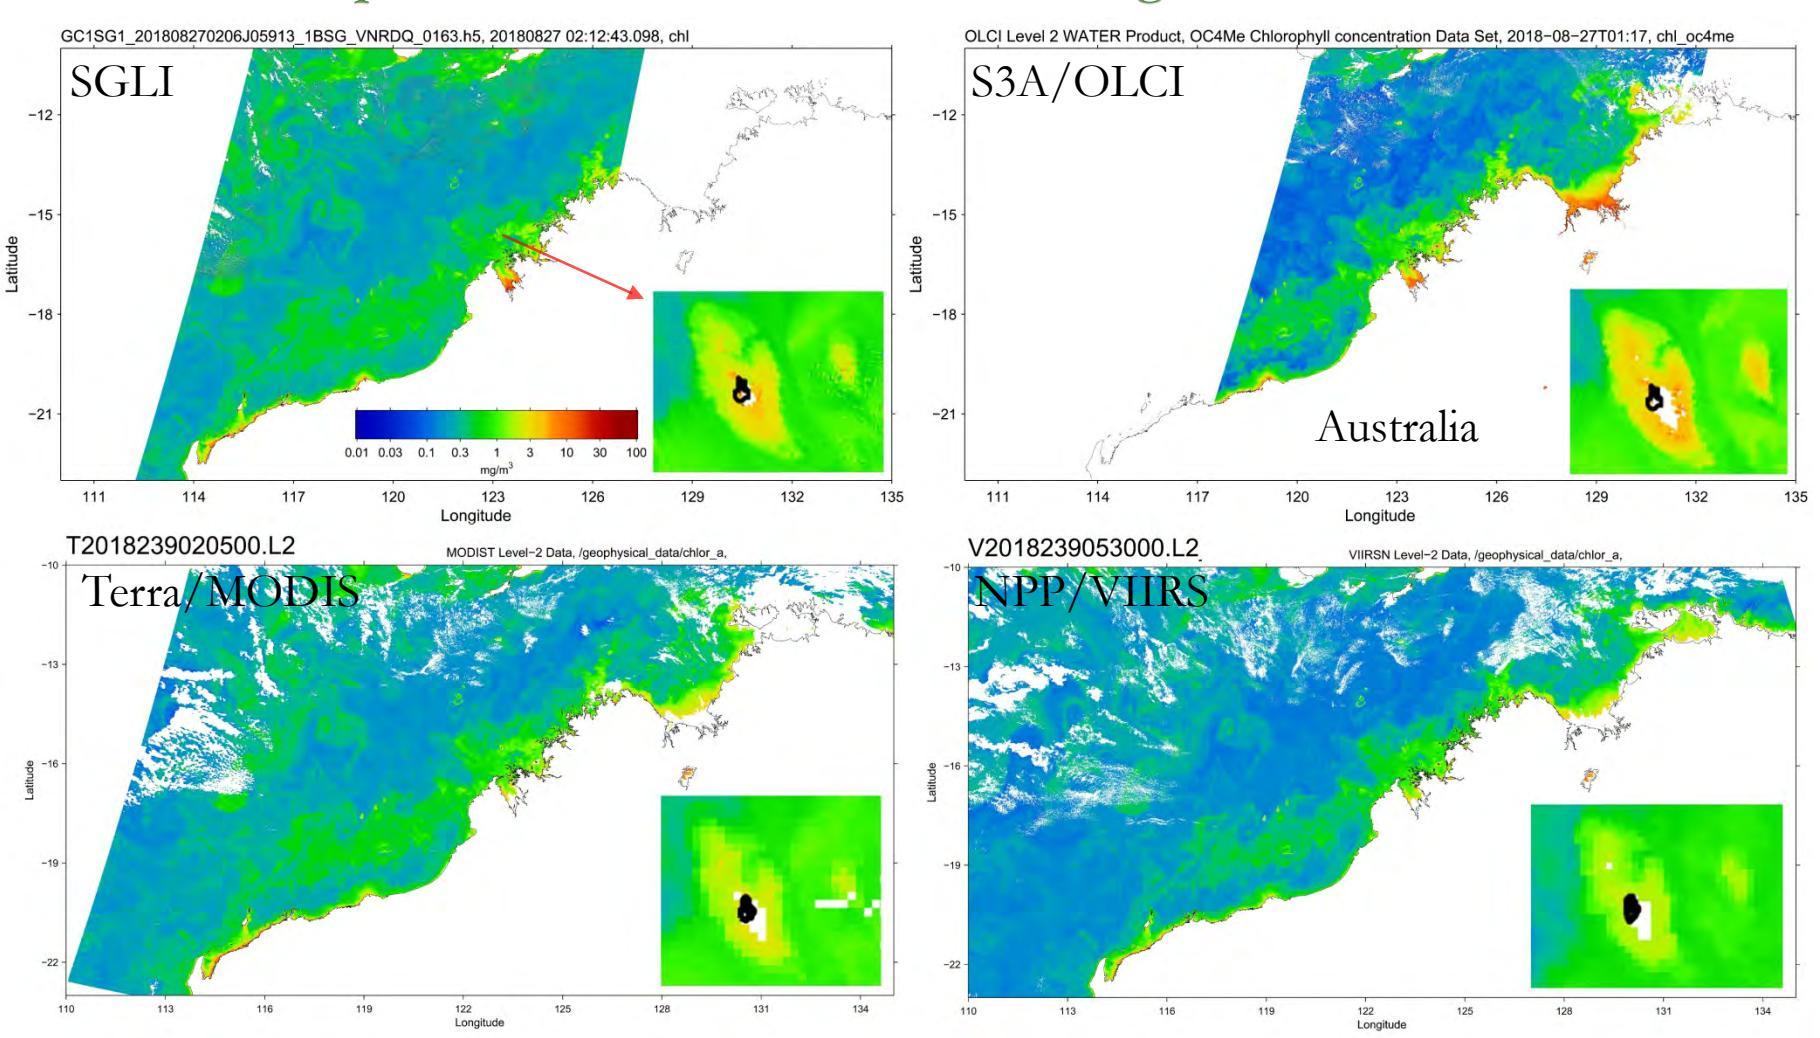
Chl-*a* derived by SGLI, Sentinel-3/OLCI (by OC4ME algorithm), Terra/MODIS, and Suomi NPP/VIIRS in the northwest of Australia on 27 Aug 2018.
